**BLISTERING OF GRAPHITE/POLYMER COMPOSITES GALVANICALLY  
COUPLED WITH METALS IN SEA WATER**

**Materials Laboratory, College of Engineering  
The University of Rhode Island**

**AN ANNUAL REPORT**

**ONR Contract # N0001491J1328**

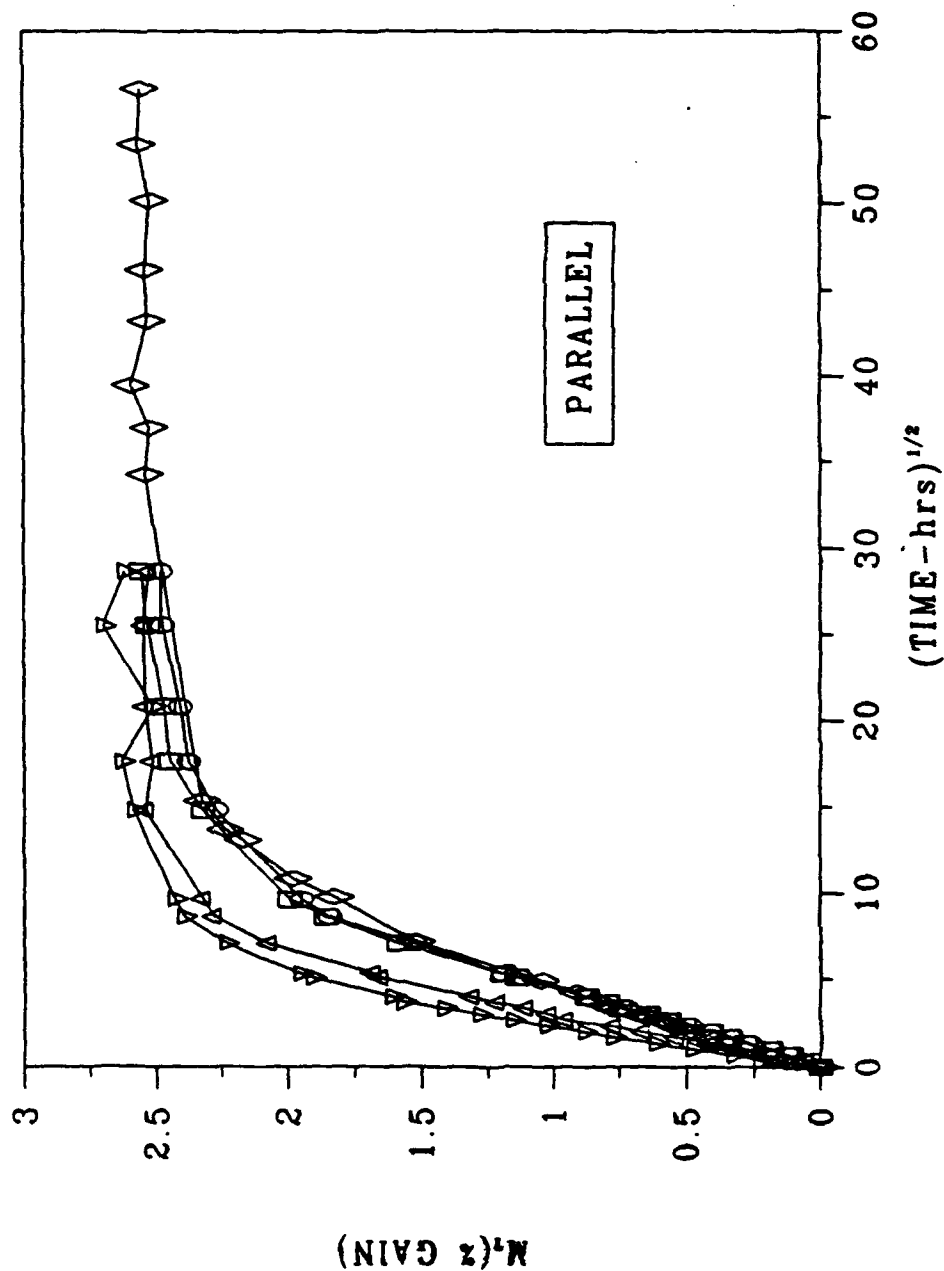
The results of the absorption experiments are shown in Figures [1], [2], [3] and [4]. Whereas figures [1] and [2] present diffusion data parallel and transverse to the fibers respectively for pure water, figures [3] and [4] present similar data for 3% NaCl solution. The ordinate in these plots is % weight gain based up on the polymer content of the composite. The curves clearly demonstrate Case I or Fickian diffusion. The absorption curves for neat resin at the same experimental conditions are shown in Figure [5]. It is difficult to conclude whether the sorption behavior of the polymer is Fickian or

Figure 1. Diffusion curves for pure water absorption parallel to the fibers in carbon/glass/vinyl ester composite. Temperature = 40°C.

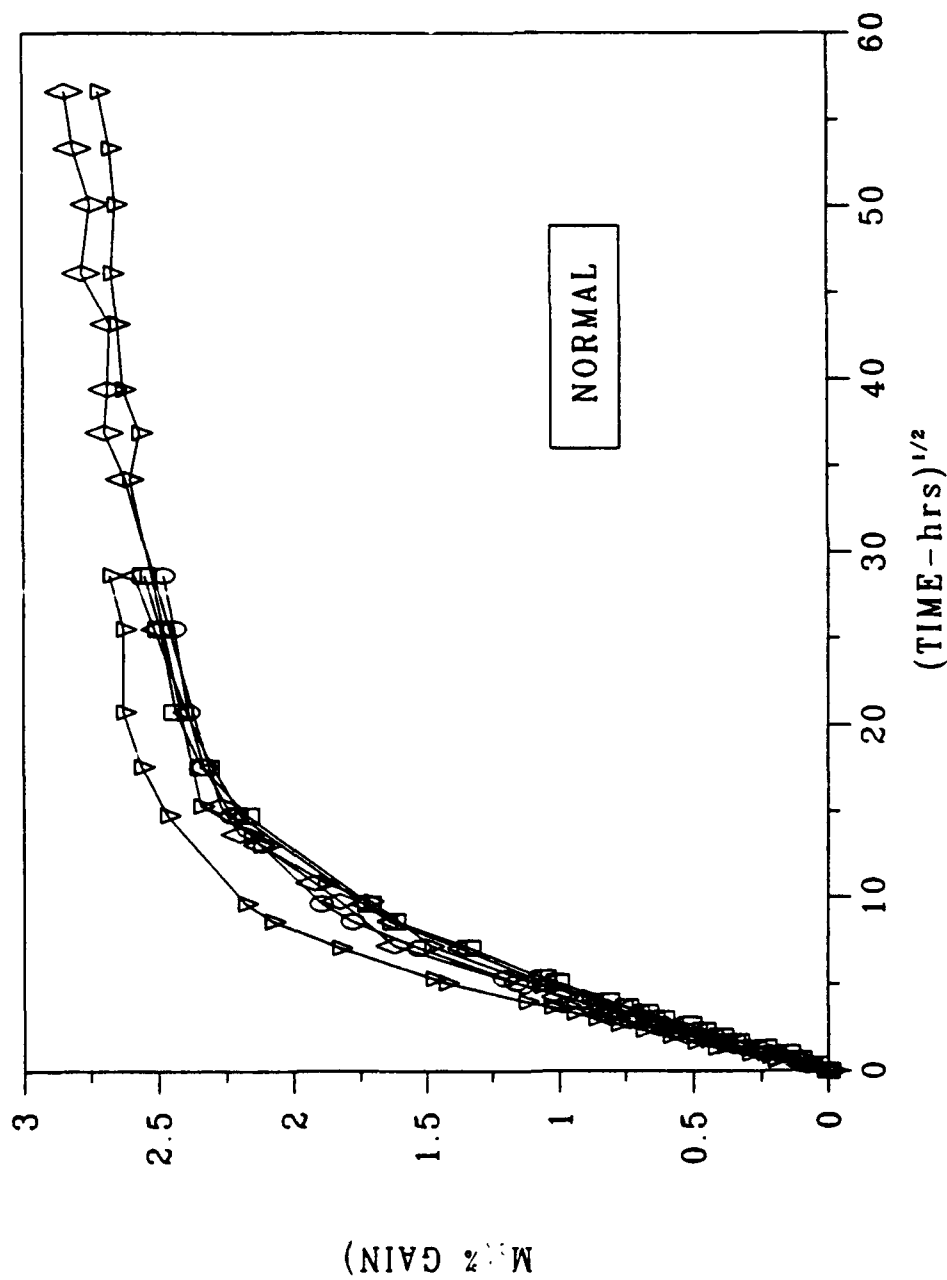
Figure 2. Diffusion curves for pure water absorption normal to the fibers in carbon/glass/vinyl ester composite. Temperature = 40°C.

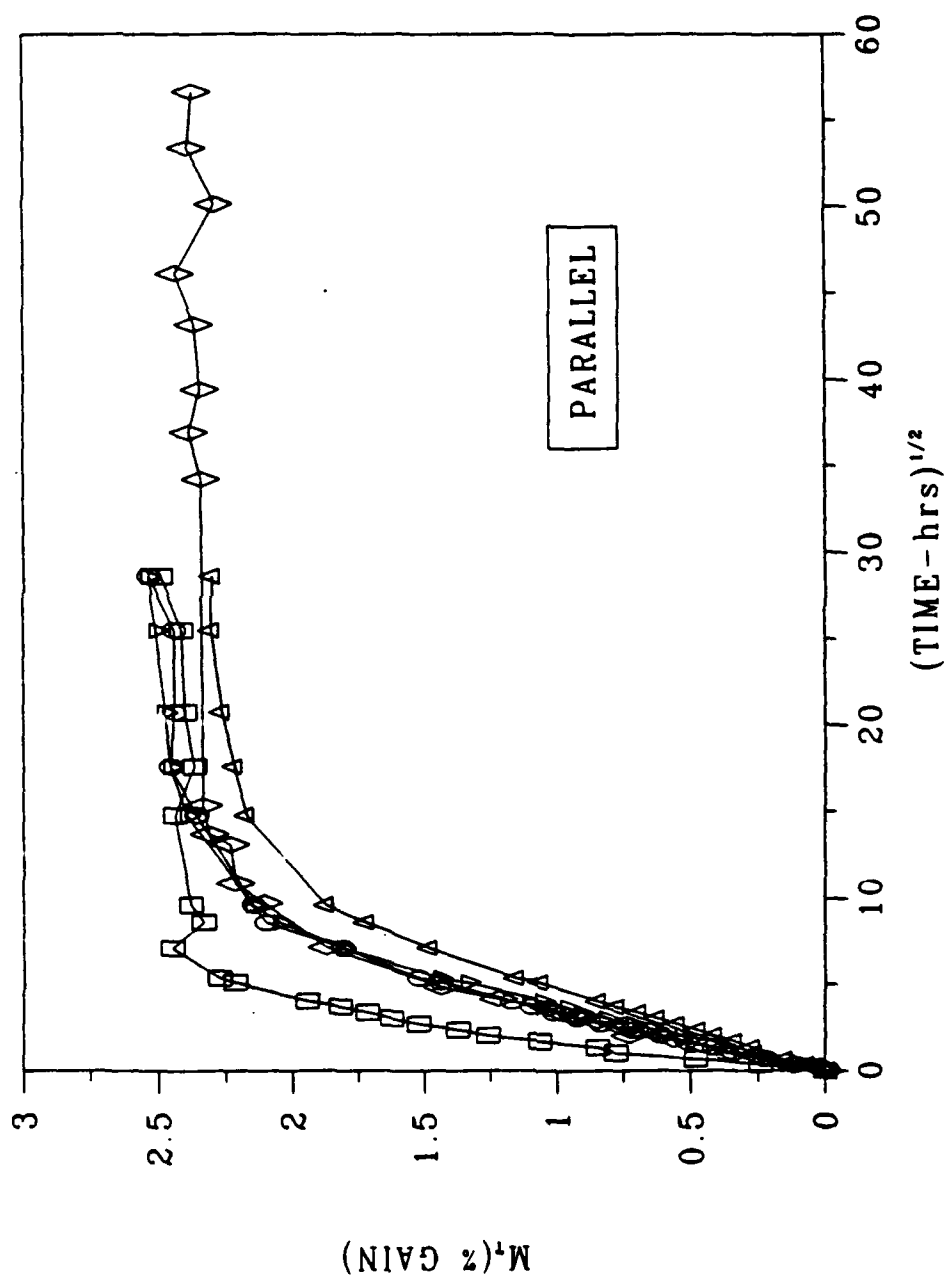
Figure 3. Diffusion curves for absorption of 3% NaCl solution parallel to the fibers in carbon/glass/vinyl ester composite. Temperature = 40°C.

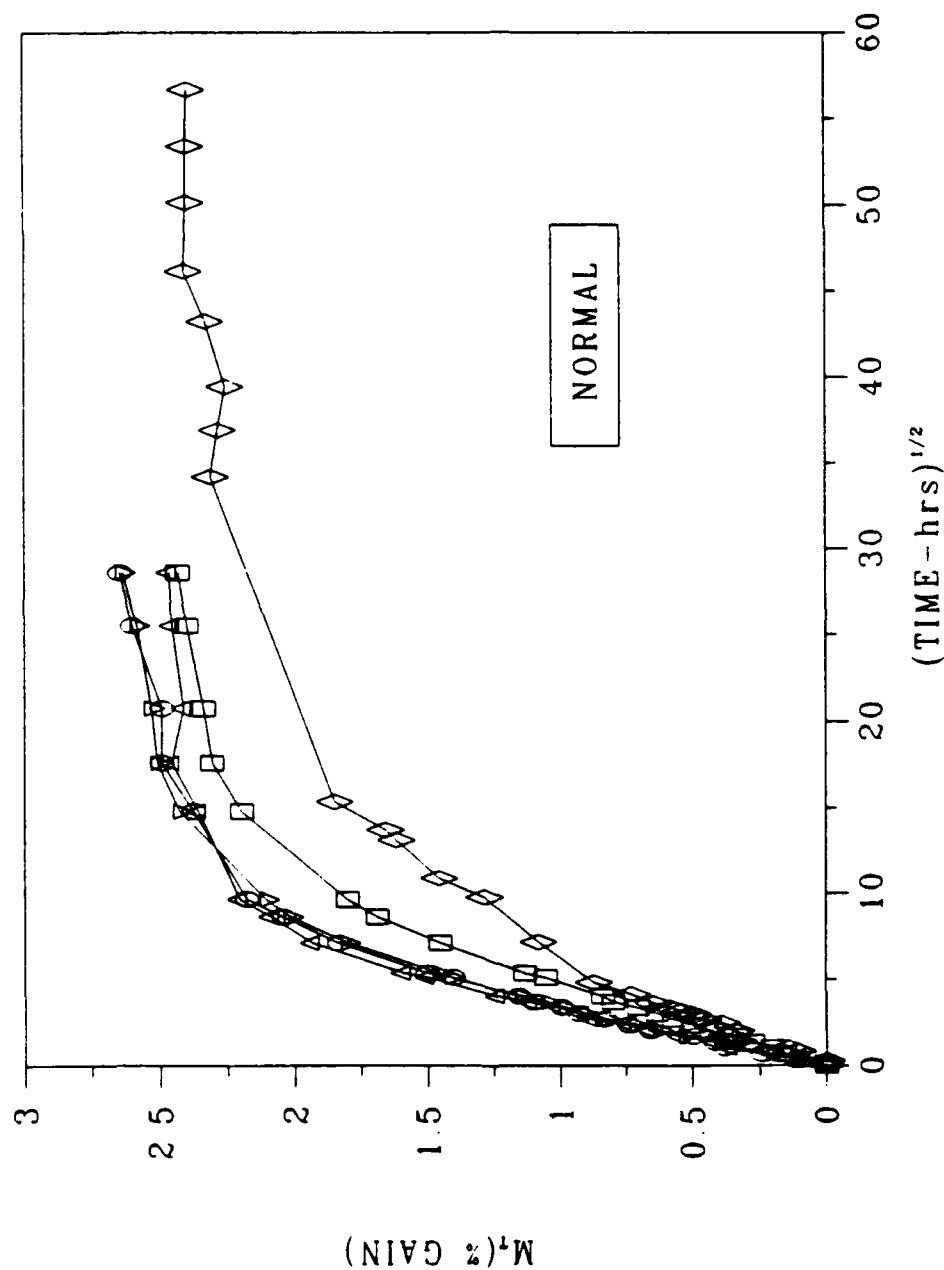
Figure 4. Diffusion curves for absorption of 3% NaCl solution normal to the fibers in carbon/glass/vinyl ester composite. Temperature = 40°C.

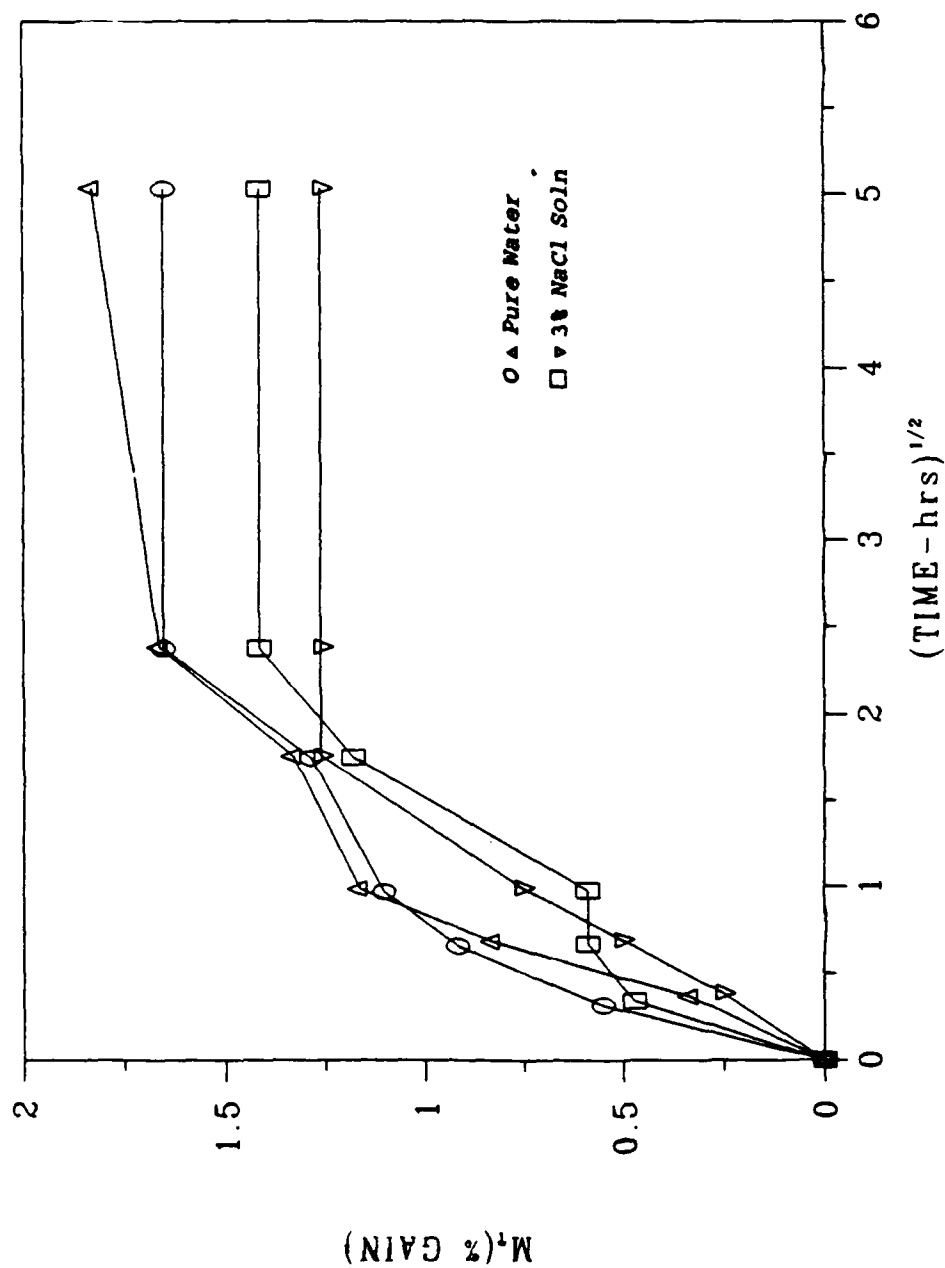
Figure 5. Diffusion curves for absorption of pure water and 3% NaCl solution in vinyl ester neat resin (as cast). Temperature = 40°C.

non-Fickian from these curves. Previous investigation by Lee [5] suggested a Fickian type absorption in similar vinyl esters. But the plateaus in the present curves support a two stage diffusion. However, this is unlikely for vinyl esters and the error could be attributed to experimental scatter. More data on water diffusion in neat resin is required to draw any conclusion. The saturation values for both the composite and the resin are presented in Table [1]. The water diffusion coefficients for the composite are also presented in Table [1]. It can be seen that the diffusion parallel to the fibers is higher than that normal to the fibers by an average 1.5 times. This is due to less obstruction in the direction parallel to the fibers. The  $D_p/D_n$ , however, is 15% lower for the case of 3% NaCl solution. Contrary to expectations, the average diffusion coefficients for pure water are lower than those for NaCl solution by 10% and 25% for parallel and normal diffusion respectively. These reductions, however, are within the range of experimental data scatter. The saturation values for the 3% NaCl are about 7% lower than those for pure water whereas theoretical prediction is that the reduction should be by about 3%. The explanation again is that these differences are within the range of data scatter. The average saturation value for the composite is about 2.5% whereas for neat resin it is about 1.6%. This huge increase of about 63% in water pick-up in the composite could be due to water accumulation at the interface because of debonding caused by water. Another possibility is the presence of thixotropes in the composite. Usually silica based thixotropes are widely used and these are greatly hydrophilic. In fact, trace amounts of silica found in the precipitates from blister fluids by EDAX analysis makes this look more plausible.

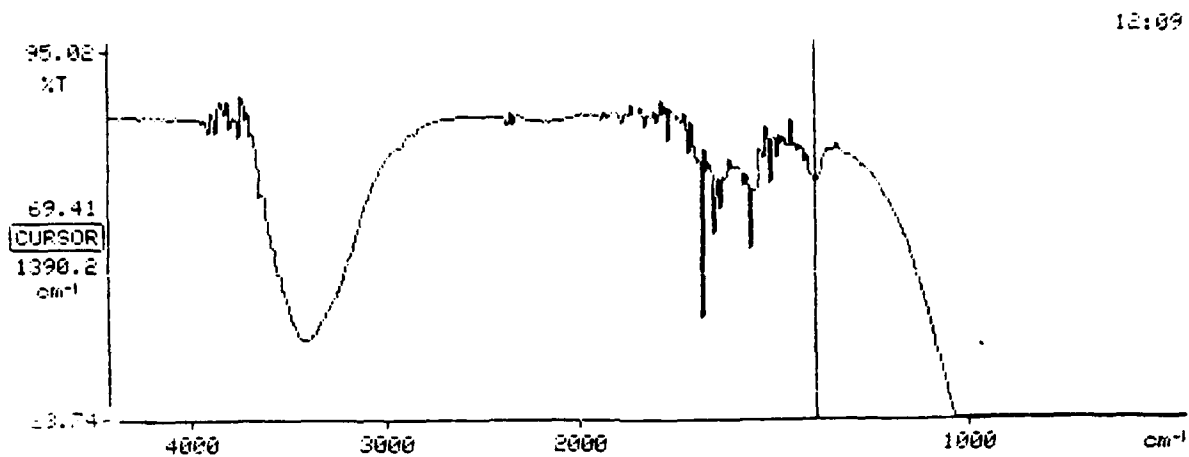
FTIR Analysis: As a first step of the process, the FTIR spectrum of the blister fluid is obtained. This spectrum is shown in Figure [10a]. The wide peak between 3000 and 4000  $\text{cm}^{-1}$  and the band between 1500 and 2000  $\text{cm}^{-1}$  are identified to be that of water. However, a small peak where the vertical cursor stands is characteristic of the blister fluid. The blister fluid being alkaline in nature, the presence of alcohols in the blister fluid may be suspected. FTIR spectra of methanol and ethanol were obtained. The peak referred to in Figure [10a] is spread out and is compared with the methanol and ethanol spectra in Figures [10b] and [10c] respectively. The particular wave number range

**Figure 10a.** FTIR spectrum of blister fluid

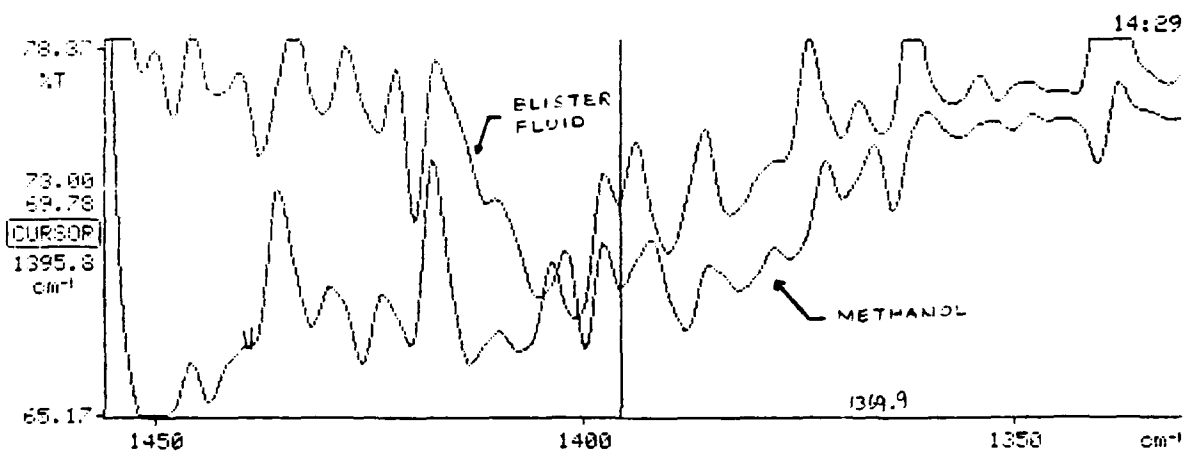
**Figure 10b.** Comparison of FTIR spectra of blister fluid and methanol.

showed is typical of O-H stretching vibrations of alcohols. These spectra reveal that the blister fluid spectrum closely follows those of methanol and ethanol although differs considerably in intensities and by minor shifts. This suggests the presence of alcohols or glycols. However what kind of alcohols is unknown. The following FTIR spectra are being obtained:

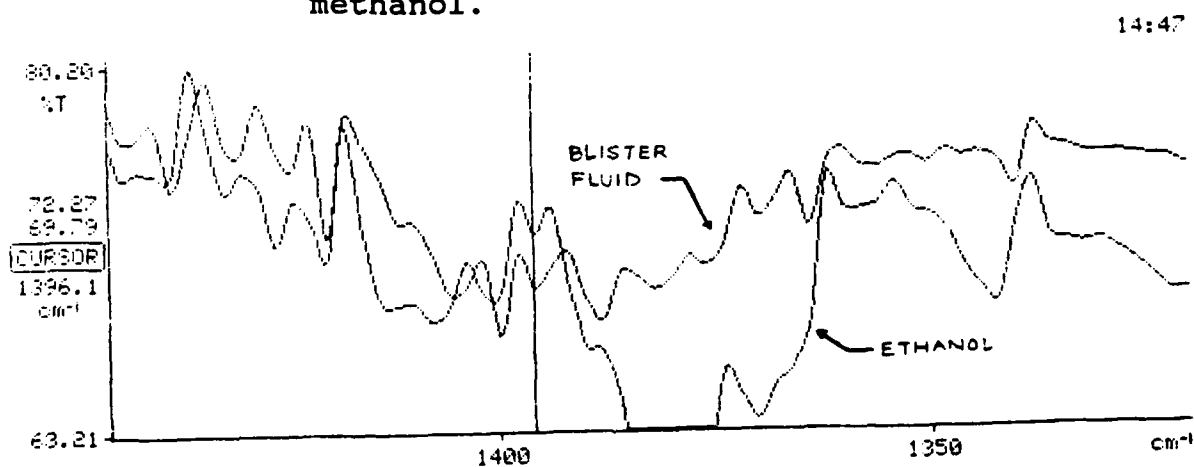
**Figure 10c.** Comparison of FTIR spectra of blister fluid and ethanol.

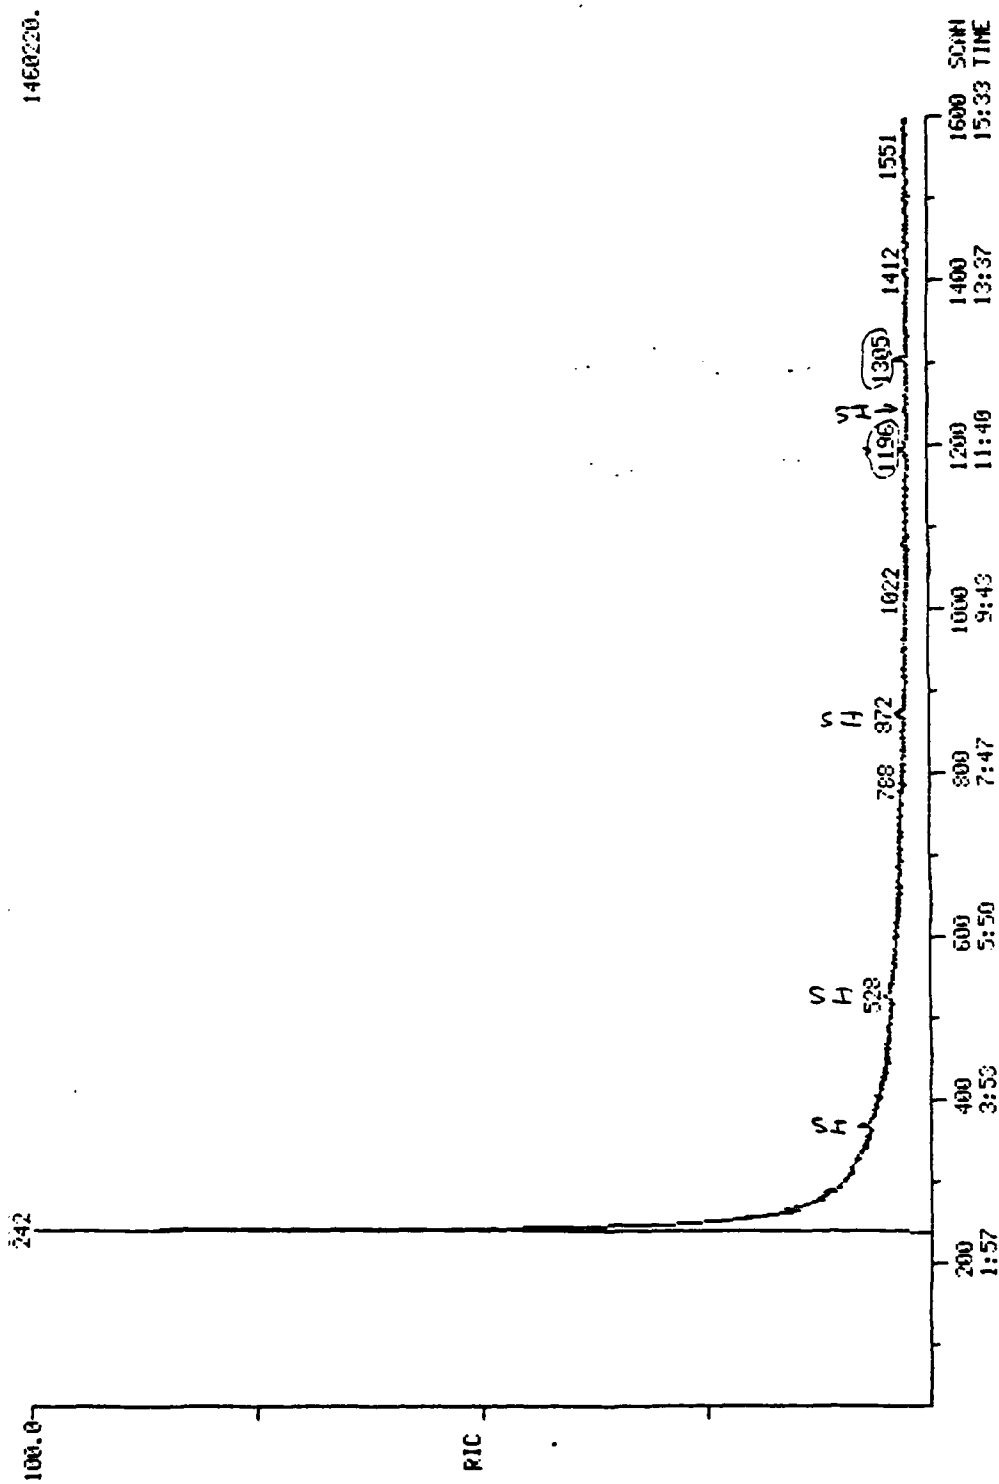
GCMS Analysis: Recently analysis of blister fluid by gas chromatograph coupled to a mass spectrometer has been performed. The solvent used was methylene chloride/acetone solution (200 microgram/liter) and the carrier gas used was helium. A 5% phenyl based capillary column was used. The chromatogram obtained is shown in Figure 10(d). The spectrum does not show any significant peaks. The reason could be that the blister fluid precipitates may not be soluble in the solvents employed or the material may not be eluting from the column. Further efforts to analyze by mass spectrometry will be made

**Figure 10d.** GCMS spectrum of blister fluid.  
IS = internal standards.

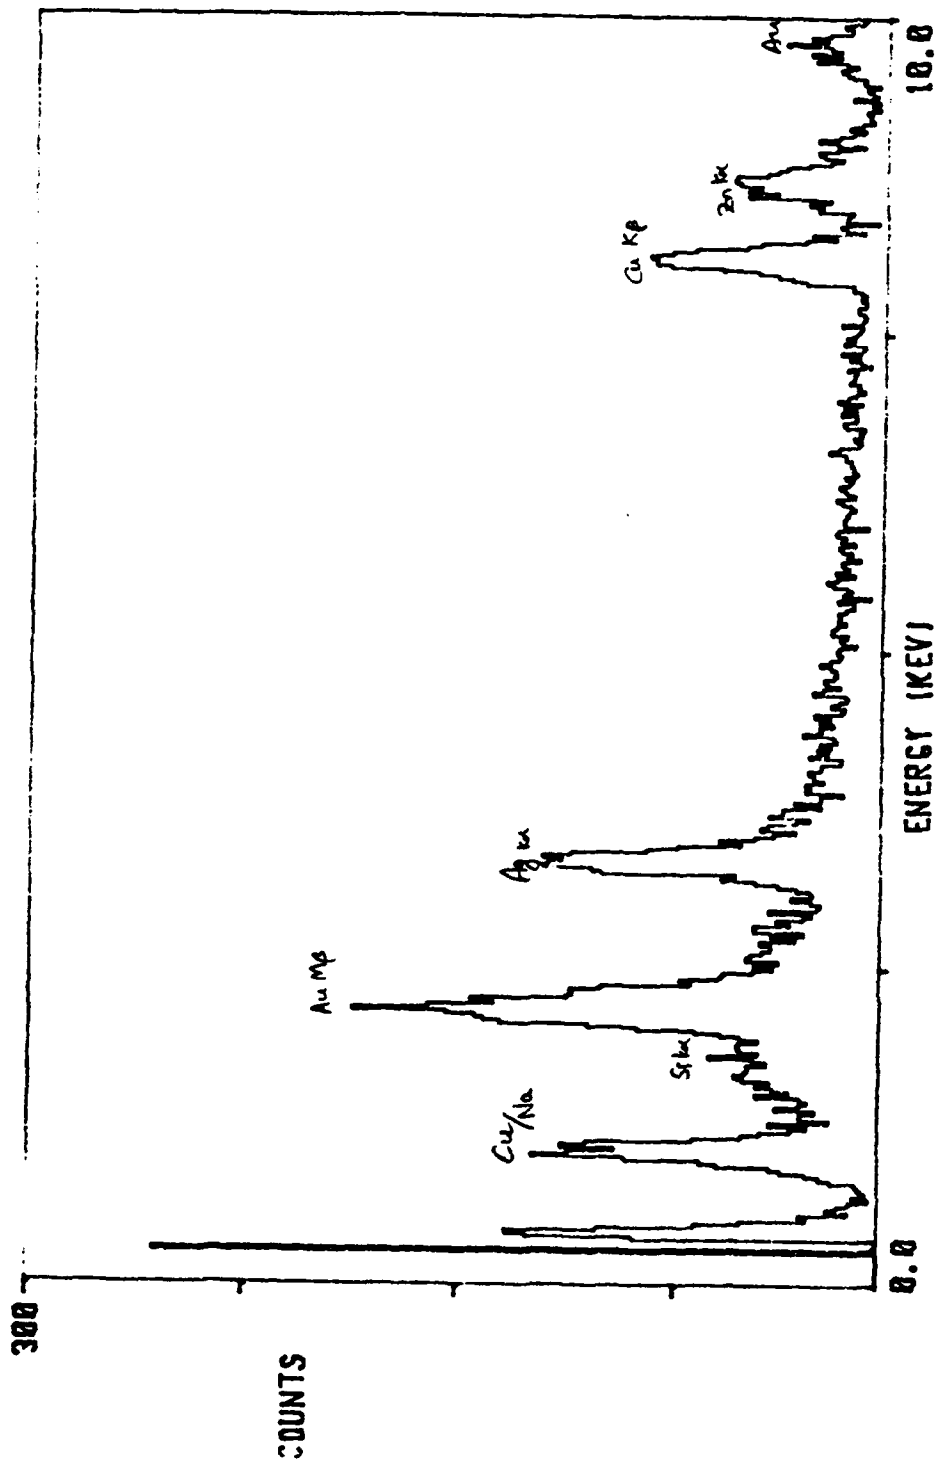
Figure 11. SEM EDAX analysis spectrum for blister fluid precipitates.
